ASSESSMENT OF DAM SAFETY OF COAL COMBUSTION SURFACE IMPOUNDMENTS FINAL REPORT

**CPS Energy
J.K. Spruce Power Plant
San Antonio, Texas**

Prepared for
*U.S. Environmental
Protection Agency
Washington, D.C.*

February 2014
Revised May 2014
Revised June 2014

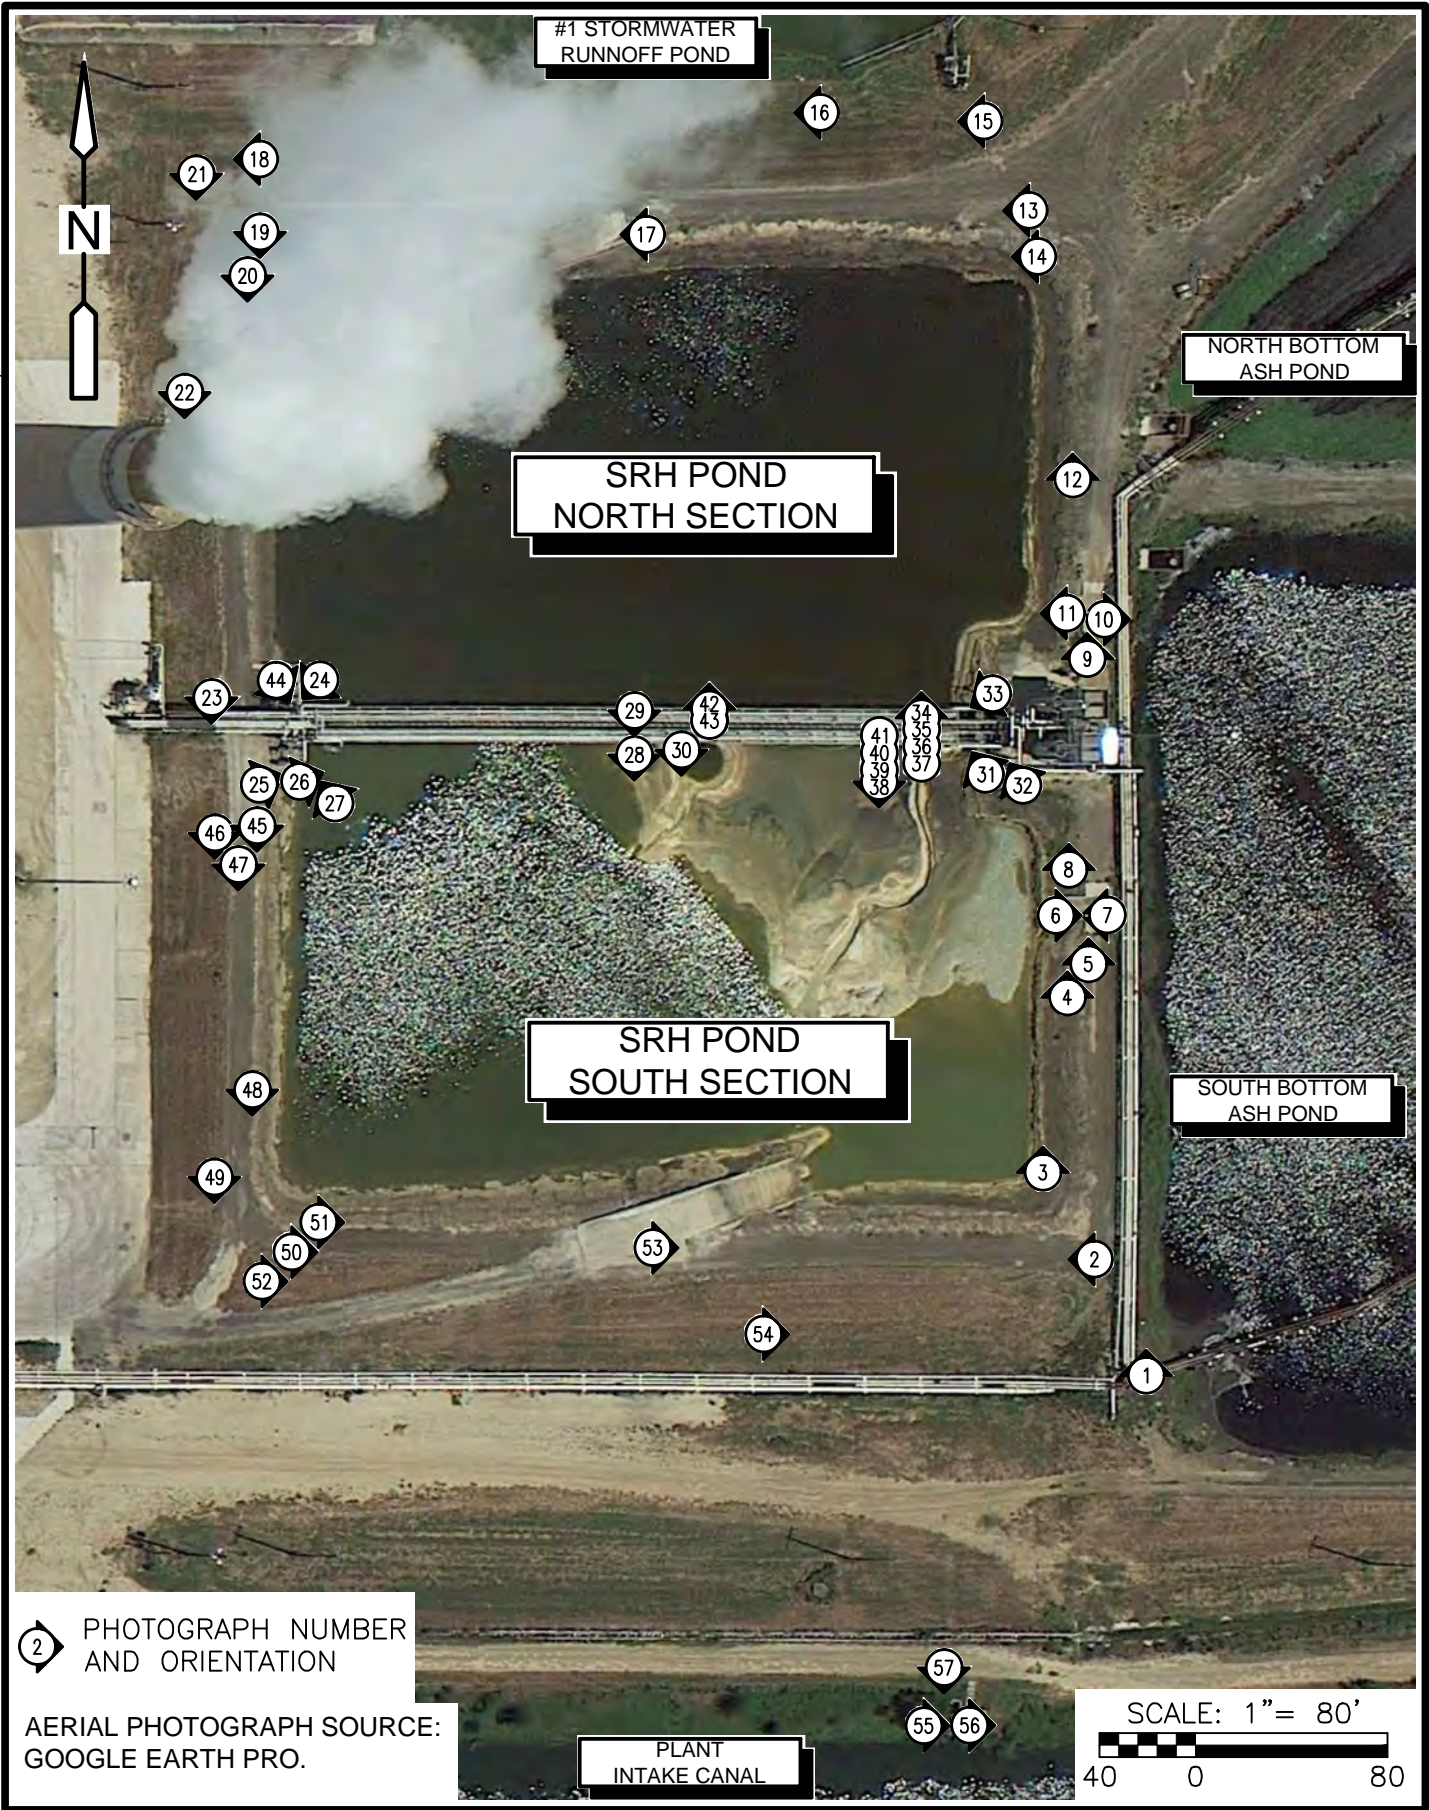
J.K. SPRUCE POWER PLANT
 SAN ANTONIO, TEXAS
 SRH POND
 FIGURE 5-1

The crest of the SRH Pond appeared to be in satisfactory condition (Photographs 3, 13, 20, and 50). The crest was approximately 15 feet wide at all embankments except at the east embankment where it widened to approximately 50 feet to accommodate the clarifier pad (Photograph 8). Two spillways that connect the SRH and South Bottom Ash Ponds were located on the east embankment crest (Photographs 5 and 9). Supports for overhead piping were located at the west embankment crest (Photograph 22). The crest of the embankments consists of compacted granular soils and gravel and is exposed to minimal vehicle traffic. No depressions or evidence of settlement were observed on the crest.

Interior slopes of the SRH Pond appear to be in fair condition (Photographs 4, 12, 14, 19, 45, and 51). Interior slopes were at 3H:1V and covered in a layer of granular material and other solids. Some sparse vegetation was observed in limited areas on the east and north embankment interior slopes (Photographs 4, 8, 9, and 17). Concrete roadway ramps into the pond for equipment access were located at the north and south embankment interior slopes (Photographs 17 and 53). Two spillway inlets were located on the east embankment interior slope (Photograph 7 and 11). Piping and sump pumps were located on a concrete pad built into the west embankment interior slope (Photograph 19 and 25). Visible portions of interior slopes did not include riprap or other armoring.

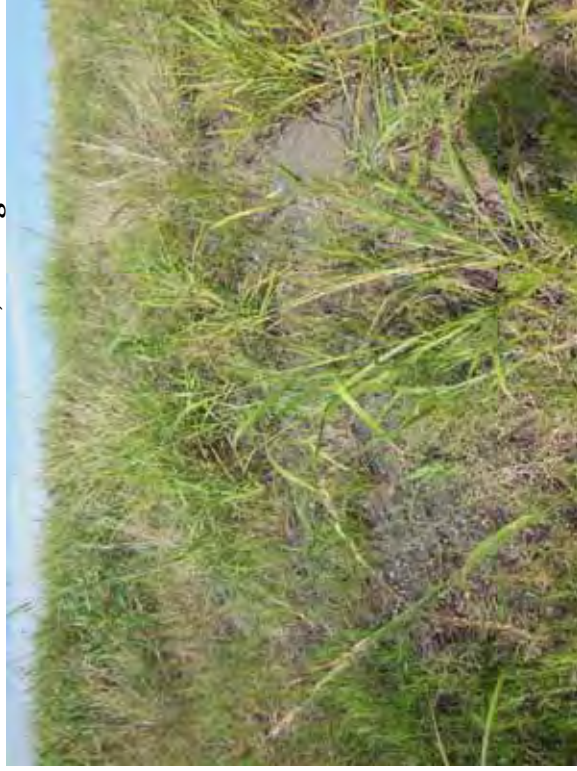
Photo 59: East embankment interior slope, looking north.

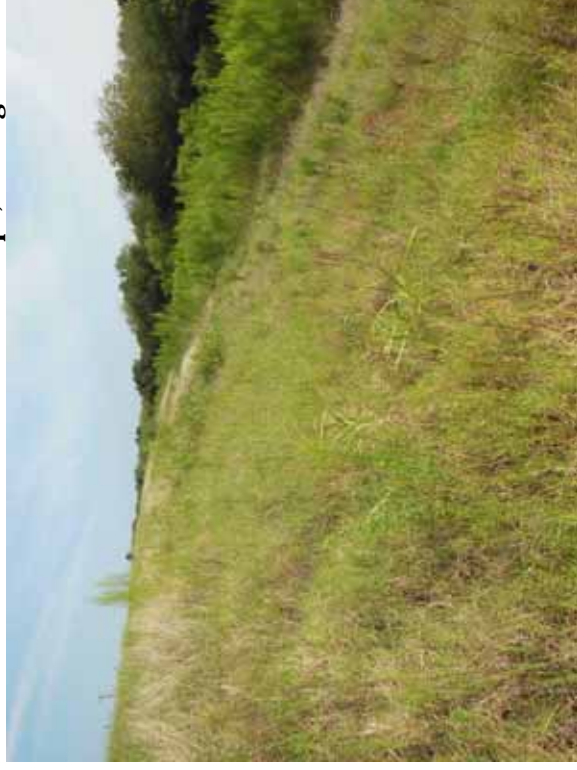
The exterior slopes of the Evaporation Pond are covered in grassy vegetation approximately 2 feet high and a few small trees and bushes with diameters less than 6 inches. Areas of loose soil were observed at the east embankment exterior slope of the Evaporation Pond and an animal burrow was observed at the west embankment exterior slope. Trees up to 12 inches in diameter were located at the toe of all embankments of the Evaporation Pond. Visible portions of interior slopes of the Evaporation Pond and SRH Pond did not include riprap or other armoring.

Photo 60: Loose soils on east embankment exterior slope.

CDM Smith recommends that vegetation on the SRH Pond and Evaporation Pond embankments be cut on a regular basis to help ensure that adequate visual observations can be made by CPS' personnel during routine inspections. CDM Smith also recommends trees (including the root ball) located at and within 15 feet of the toe of all embankments of the Evaporation Pond be removed and the excavations filled with compacted fill under the supervision of a qualified dam engineer. Animal control measures should be implemented to reduce embankment disturbance. All affected areas should be backfilled with compacted fill, graded to match the surrounding topography, and seeded with appropriate non-invasive grassy vegetation. It is also recommended that riprap be placed on interior embankment slopes in areas with little or no armoring.

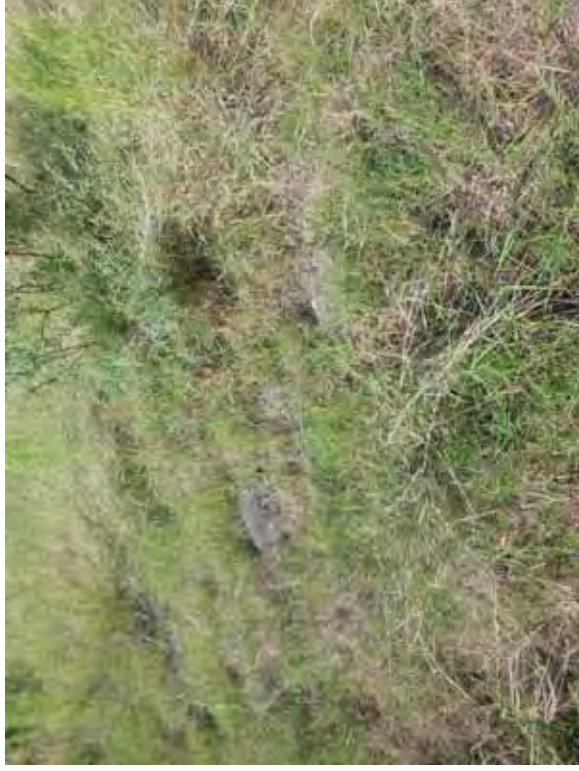
Photo 61: East embankment exterior slope, looking north.

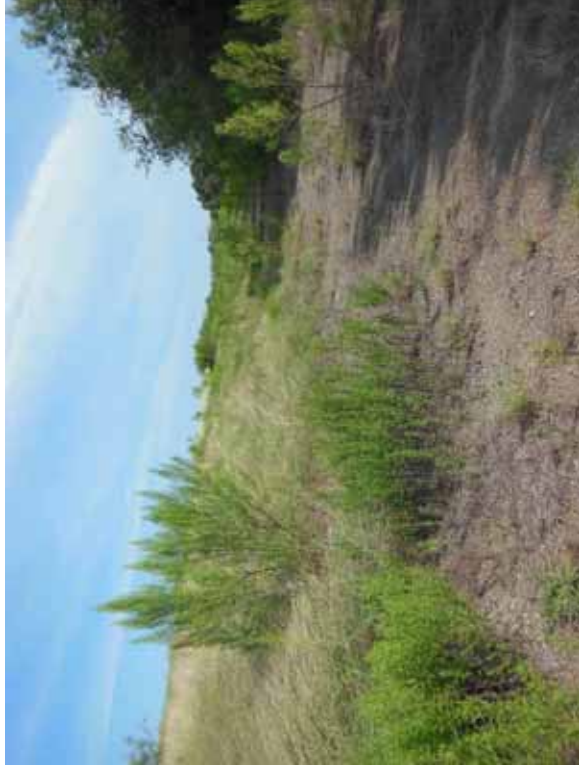
Photo 62: Loose soils on east embankment exterior slope.

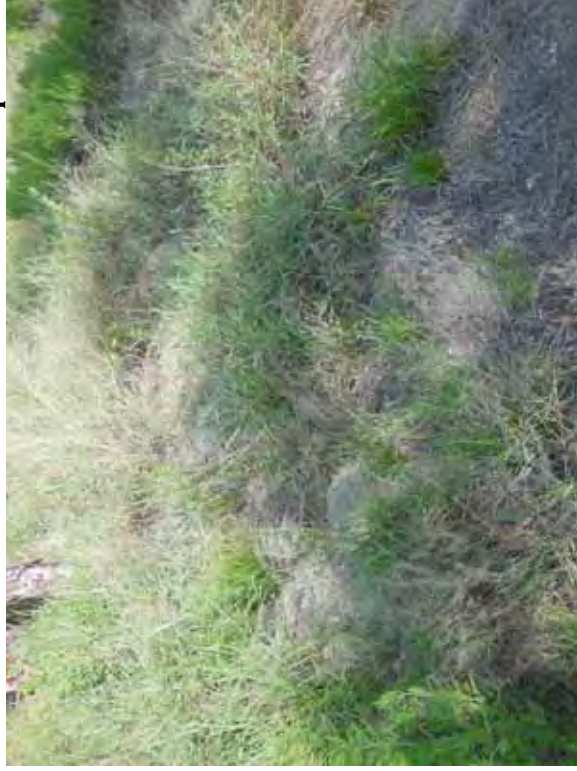
Photo 63: East embankment exterior toe, looking north.

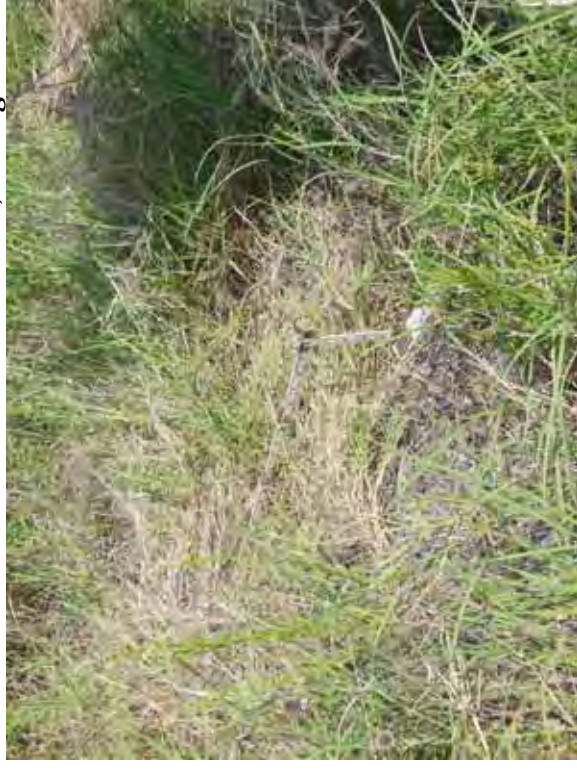
Photo 64: Loose soils near east embankment exterior toe.
